ACCIDENT REPORT FATAL FACTS

ACCIDENT SUMMARY No. 54

Accident Type:	Fall from Roof

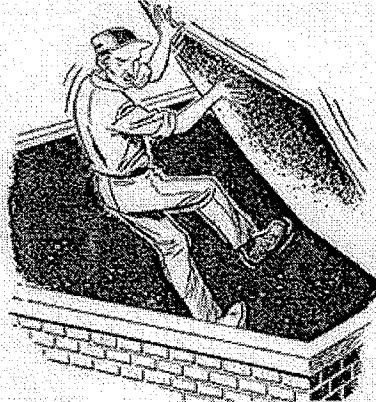
A roofer, handling a piece of fiberboard, backed up and tripped over a 7½ inch parapet. He fell more than 50 feet to ground level and died of severe head injuries.

Inspection of the accident site revealed that there was neither a safety monitoring system/warning lines or a motion-stopping-safety (MSS) system in use during the installation on the roof of the building. Also, there were two unguarded duct openings on the roof.

1. Provide standard railing for temporary floor opening [29 CFR 1926.500(b)(7)].
2. Provide employees engaged in built-up roofing work on low-pitched roofs with a safety monitoring system on roofs of fifty feet or less in width where mechanical equipment is not being used [29 CFR 1926.500(g)(1)(iii)].

3. Erect warning lines around all sides of the work area during the performance of built-up roofing work on low-pitched roofs where the ground to cave height is greater than 16 feet [29 CFR 1926.500(g)(3)(i)].

4. Assure that employees engaged in built-up roofing work have been trained and instructed in the nature of fall hazards in the work area near a roof edge; the function, use and operation of the MSS system, warning line, and safety monitoring systems to be used; the correct procedures for erecting, maintaining, and disassembling the systems to be used; the role of each employee in the safety monitoring system when this system is used; the limitations on the use of mechanical equipment; and the correct procedures for the handling and storage of equipment and materials [29 CFR 1926.500(g)(6) (ii)(a) through (f)].

5. Erect an MSS system along all unprotected roof sides and edges [29 CFR 1926.500 (g) (5)].
